**DEPARTMENT OF TRANSPORTATION****DIVISION OF ENGINEERING SERVICES**

Caltrans Quality Assurance (QA) Inspector, Mike Hasler was present to observe the fitup, welding and related activities associated with the fabricating of Caltrans Mock-up, 77M, 89M, 114M and U-Rib Trial Assembly, for the San Francisco Oakland Bay Self Anchored Suspension Bridge, at Zhenhua Port Machinery Company (ZPMC) facility on Changxing Island.

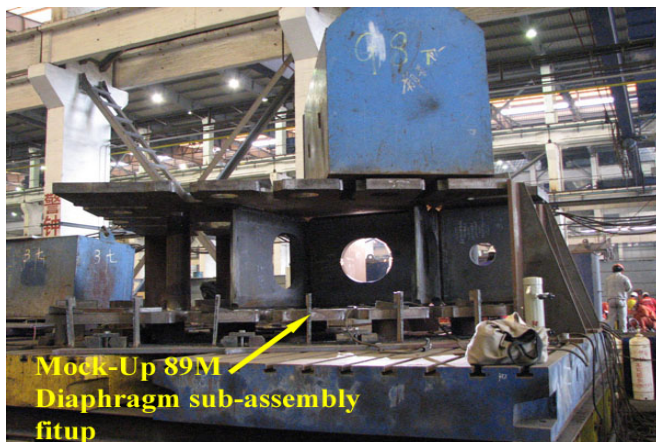
- Mock-Up 89M Diaphragm Sub-Assembly: Caltrans QA Inspector performed dimensional verification of the fitup of the top diaphragm plate assembly (SA13/p1236) joining web plates (p842, p138, p720, p721) to the bottom diaphragm plate assembly (p1235). The assembly was inspected for web fitup to the top and bottom diaphragm plates, distance between diaphragm plates and web locations. The dimensional variation between required dimensions and measured dimensions was 2mm and less. Following digital picture illustrates diaphragm assembly at the workstation.
